# Troubleshooting Chrome Conversion Coatings on Aluminum

# W. John Fullen

While the chrome conversion coating process is generally reliable defects can arise unexpectedly. This presentation is intended to provide processors with an extensive troubleshooting tool when conversion coating failures are encountered.

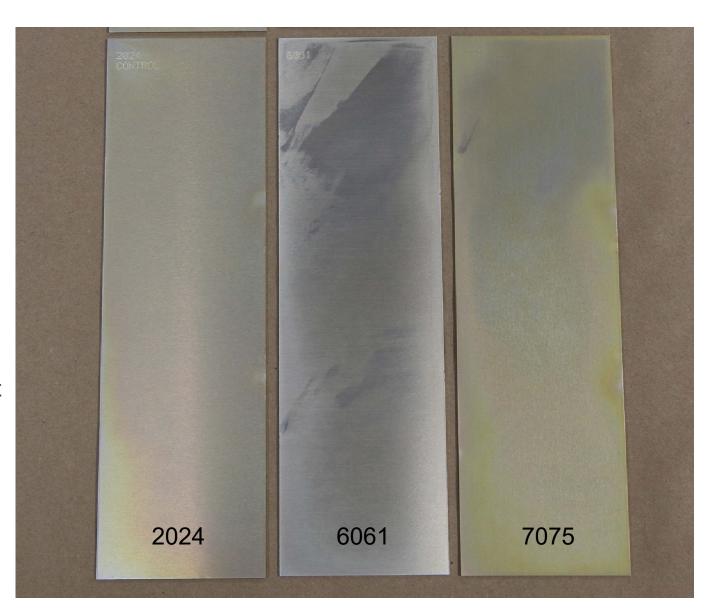
- Solvent Wipe
- Alkaline Clean
   10 min
- Deoxidize5 min
- ChromeConversion Coat1 min

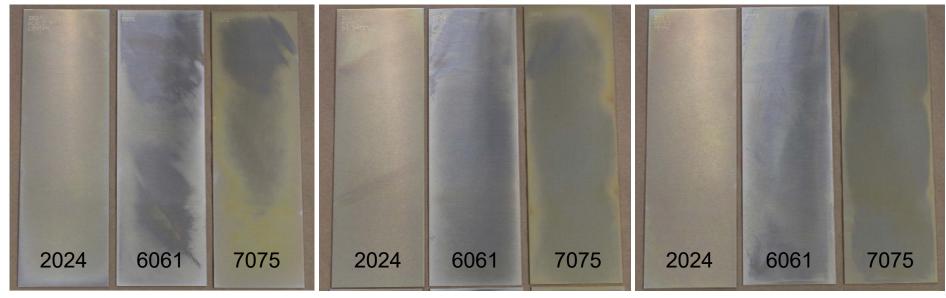
# Coating Defect Selective (Streaky/Blotchy) DI Water Rinse

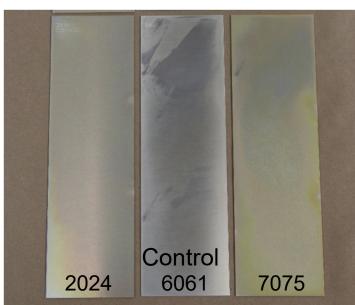
Alkaline Clean Contamination

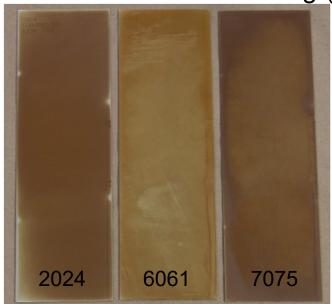
Aggressive Spray Rinse

# Coating Defects Dull Brown/Loose Coating (Powdery)

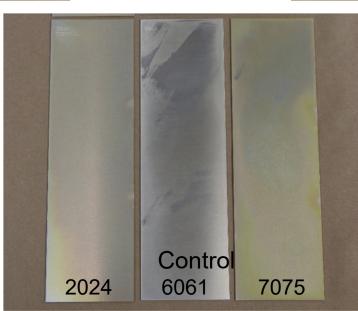
High Time 6 min

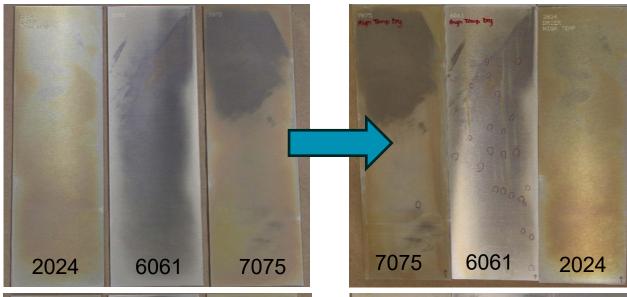
Coating Defects
Salt Spray Failures

High Drier Temp 180 F

- Drying conversion coating above 160F or for long dry times
  - A mud-cracking phenomenon of the conversion coat surface can happen which then gives a salt spray solution easy access to the unprotected aluminum surface.
- Drying conversion coatings below 90F
  - · Perhaps, the newly formed amorphous gel coating does not properly coalesce.
