NASF SURFACE TECHNOLOGY WHITE PAPERS 79 (3), 1-15 (December 2014)

Aluminum Surface Finishing Corrosion Causes and Troubleshooting

by
W. John Fullen*
Boeing Research and Technology
&
Jennifer Deheck
Boeing
Seattle, Washington, USA

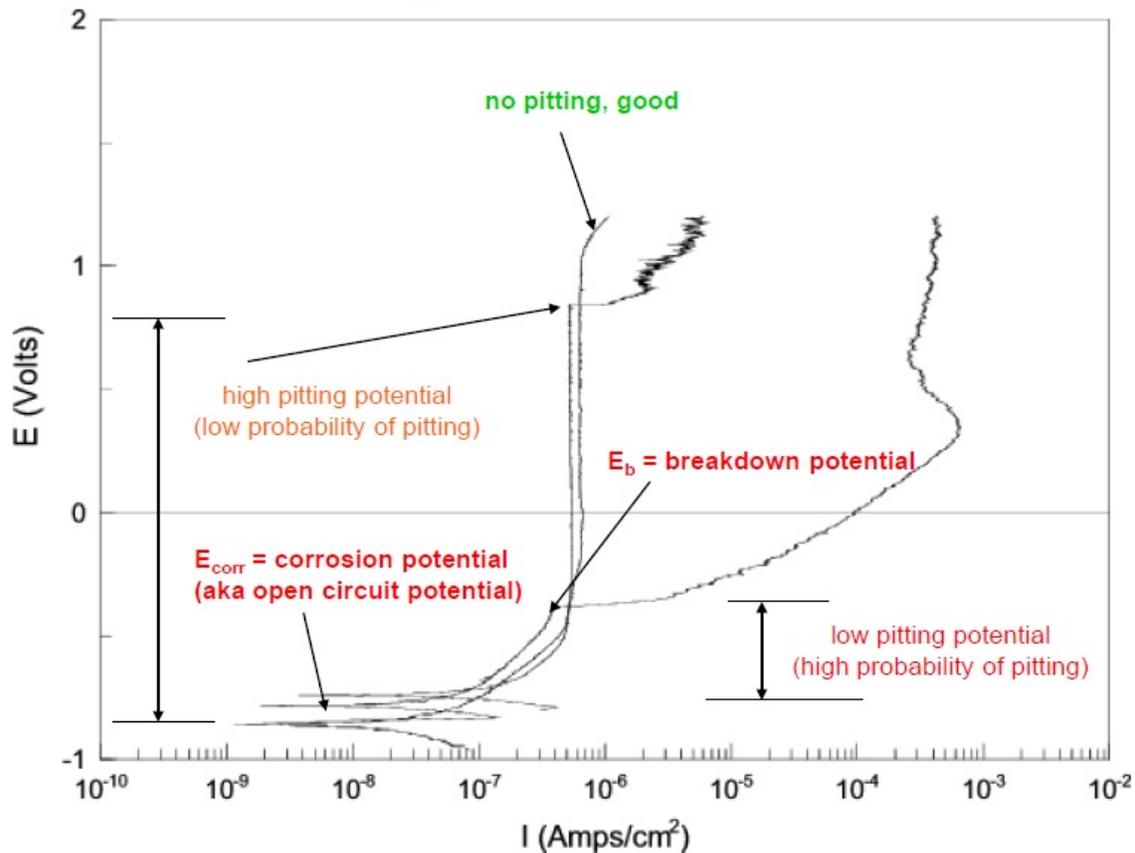
For this electrochemical potentiodynamic method, potential (volts) versus current density (amps/cm²) is evaluated. The voltage starts cathodic (negative) and is slowly ramped up while measuring current. Two key voltage levels are marked on the scan. The first is corrosion potential (E_{CORR}), which is the potential at electronic neutrality, also known as the open circuit potential. The other key voltage level is breakdown potential (E_b), which is the potential at which the anodic polarization curve shows a marked increase in current density, leading to breakdown of the passive film and pit initiation. Consequently, the closer E_b is to E_{CORR} , the greater the probability that pitting will occur (Fig. 1).

Figure 1 - Pitting potential scan.

The benefit of this type of measure is that the value can be compared to other process solutions or to new-versus-aged processes to determine the likelihood that a process solution contributes to pitting. It is possible, then, that pitting potential values, where $E_{PIT} = E_b - E_{CORR}$, may be determined for reference materials. These values could enable the proactive dumping of tanks before the onset of corrosion issues. For instance, this test method has conclusively demonstrated that chloride ion concentration in the range of 100 to 150 ppm in conjunction with other interacting ion contaminants could contribute to pitting. And, chloride ion concentration greater than 150 ppm would most likely cause pitting.

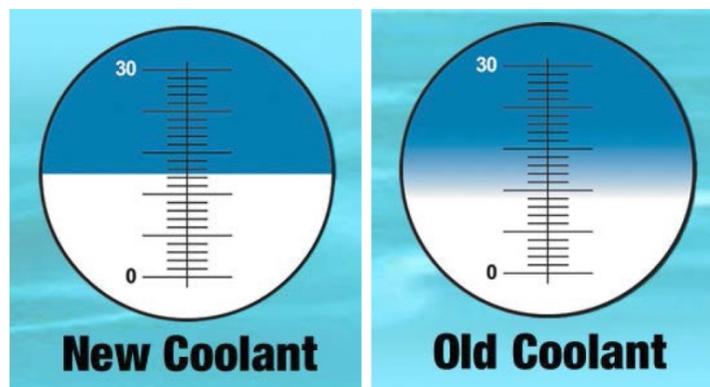
It has been reported that more than half of all occurrences of metallic corrosion have been related to contact with microorganisms.⁸ In metal finishing operations, coolants that are not well maintained are often first noticed when they emit an odor similar to rotten eggs. This is attributable to small amounts of hydrogen sulfide released as a byproduct of the enzymatic action of sulfate-reducing bacteria (SRB).⁹ Further evidence of coolants that are not well maintained is analysis of the coolant concentration using a Brix refractometer. A reading that fails to show a clear line is an indication the coolant is inundated with tramp oils (Fig. 2).

Figure 2 - Tramp oil makes reading a Brix Refractometer difficult.

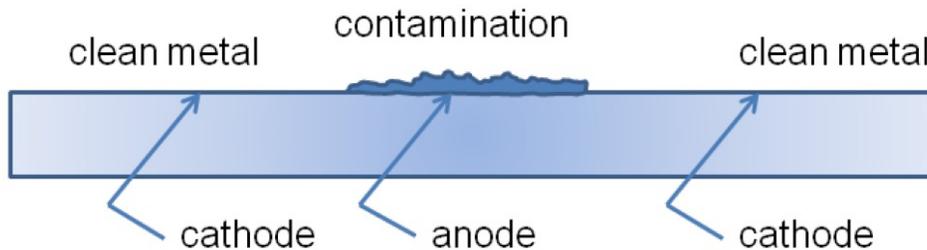
Another mechanism of metalworking-fluid induced corrosion can be caused by coolant that is allowed to dry on the part, causing a condition in which a differential oxidation cell can form (Fig. 3).¹⁶ The corrosion pattern typically resembles a halo on the part surface.

Figure 3 - Formation of differential oxidation cell.

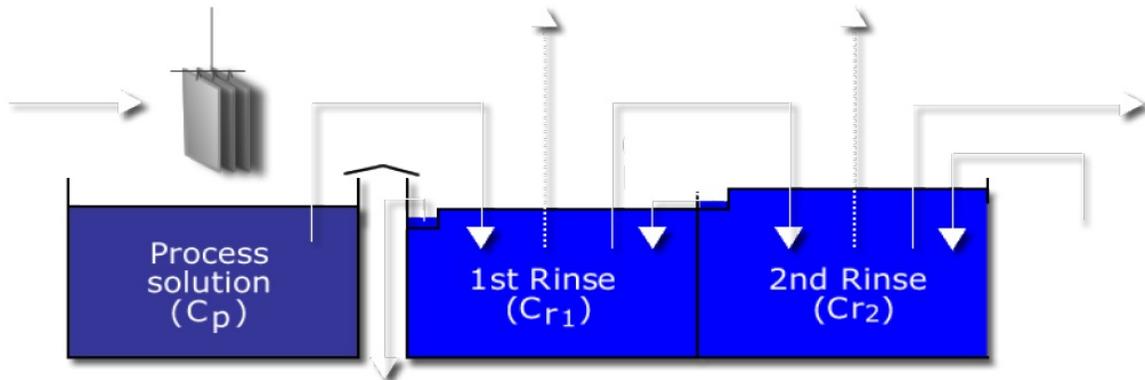
The most efficient means of rinsing makes use of a double countercurrent rinse (DCCR) system (Fig. 4).²² Because two rinse tanks are used, the most abundant process solution is water, which can contribute significantly to aluminum pitting issues.

Figure 4 - Double countercurrent rinse.

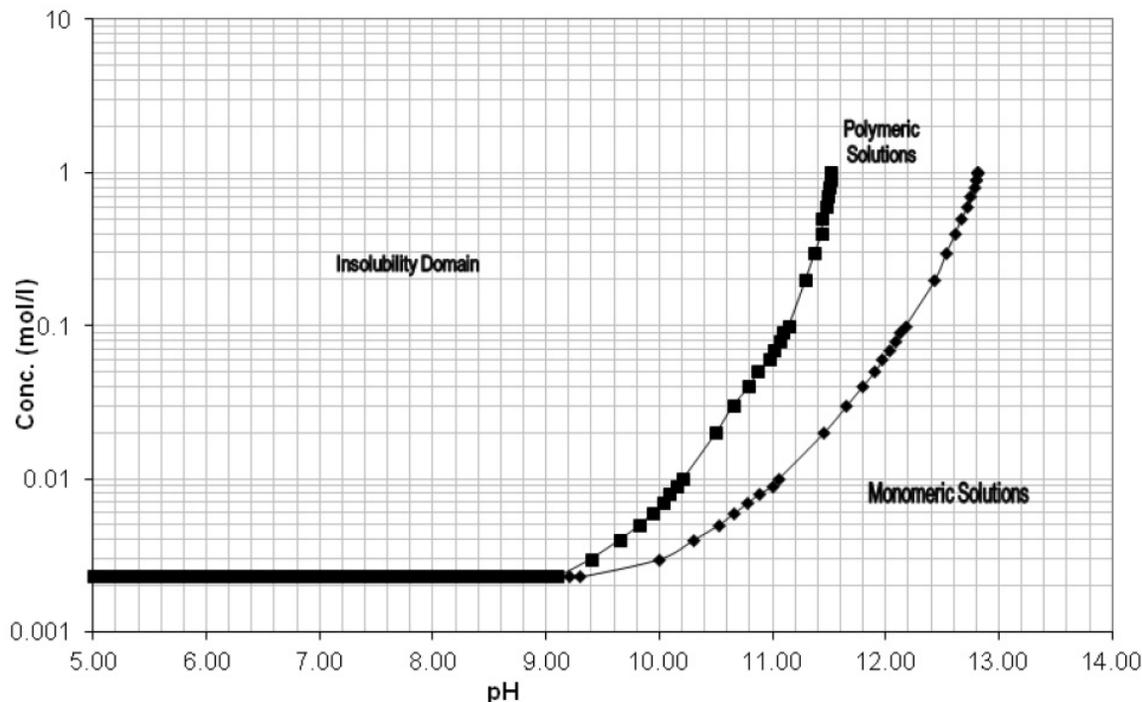
Since aluminum is only stable in a pH range of 4 to 9, these types of process solutions need to have a corrosion inhibitor package as part of their formulation. Sodium metasilicate (Na_2SiO_3) is commonly used, but as the solution ages and is continuously exposed to process temperatures above ambient (115° to 170°F), these silicates irreversibly precipitate, leaving the parts vulnerable to alkaline attack (Fig. 5).²⁸

Figure 5 - pH versus concentration of silicates.

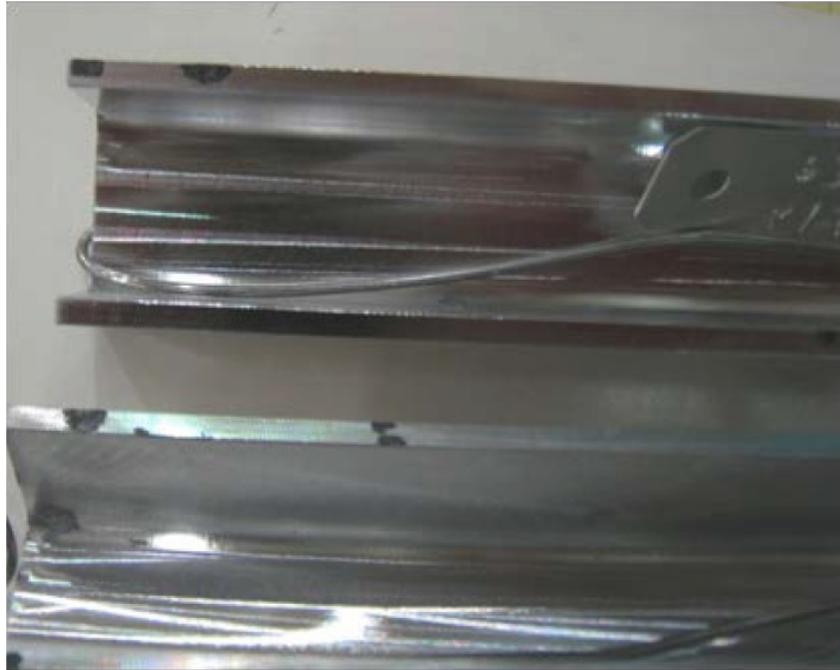
Sodium tripolyphosphate (STTP) is an alkalinity builder constituent, and over time with heat in a hydrolysis reaction, it releases free acid. The free acid release lowers the solution pH. The lowered pH affects the corrosion-inhibitor package component (sodium metasilicate), putting it into a phase of irreversible precipitation (Fig. 6).

Figure 6 - Corrosion caused by alkaline degreaser with depleted silicates.

To prevent the scenario that leads to the phase of irreversible precipitation, the solution pH should be monitored and maintained with the addition of hydroxide (NaOH or KOH) at a pH level dependent on the solution concentration.²⁹

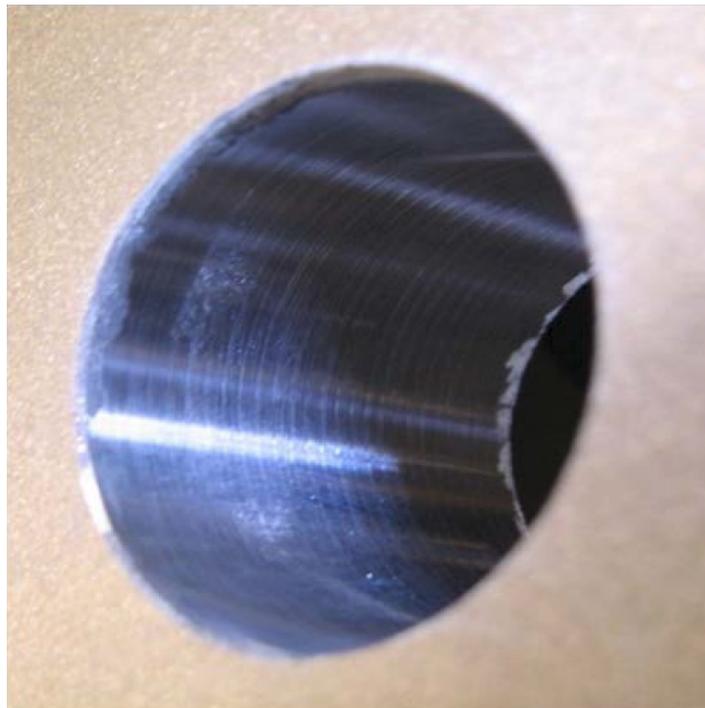
The fact that several conditions in addition to the use of the proprietary lubricant need to be met to initiate corrosion demonstrates the difficulty sometimes faced when trying to identify the cause of corrosion on a part (Fig. 7).

Figure 7 - Corrosion at hole edge.

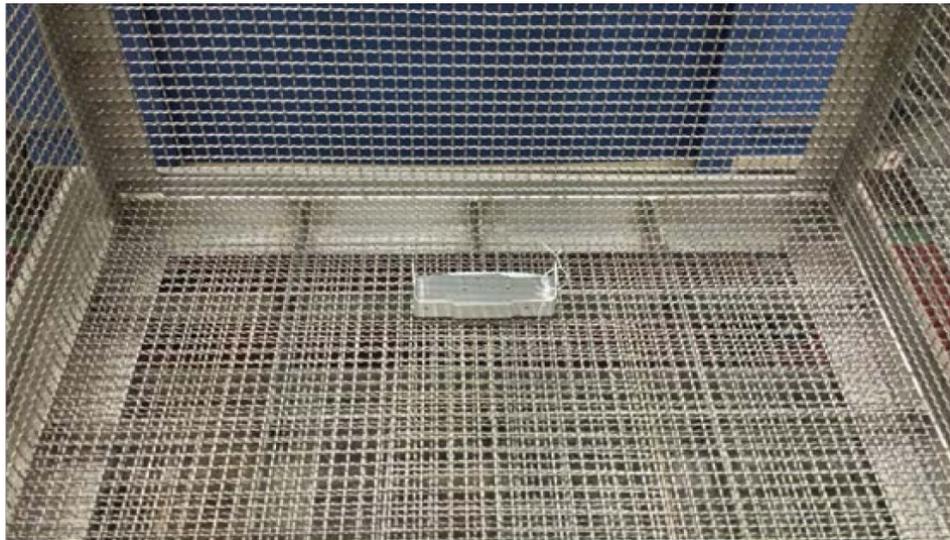
Figure 8 - Small part in large basket.

Even if an alkaline cleaner is pristine, a poor part load choice can create a galvanic cell, such as when a large basket is used to process a small part load (Fig. 8).

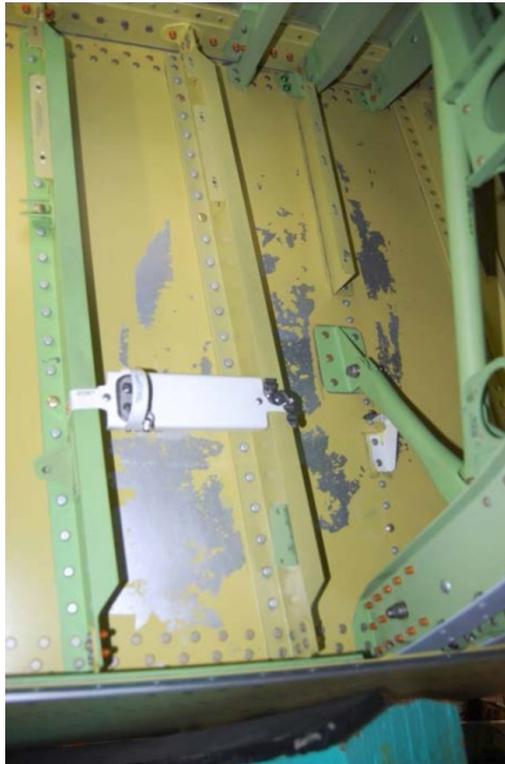
Oftentimes, penetrant inspection indications are the first to notice that a problem may exist with the deoxidizer process solution in the form of contamination or incomplete smut removal. At Boeing, process perturbation experiments led to the conclusion that the combination of short deoxidizer immersion time and long rinse immersion times can cause incomplete smut removal. This condition is not readily apparent during processing, since a water-break-free surface is achieved and the part has no visible discoloration. However, if incomplete smut removal is suspected, the parts could be simply inspected by white-glove hand wiping of the part surface to check for loose nonvisible smut. Of course, possibly of more concern is that this condition left unabated could lead to catastrophic paint adhesion failures (Fig. 9).

Figure 9 - Paint adhesion failure during assembly.

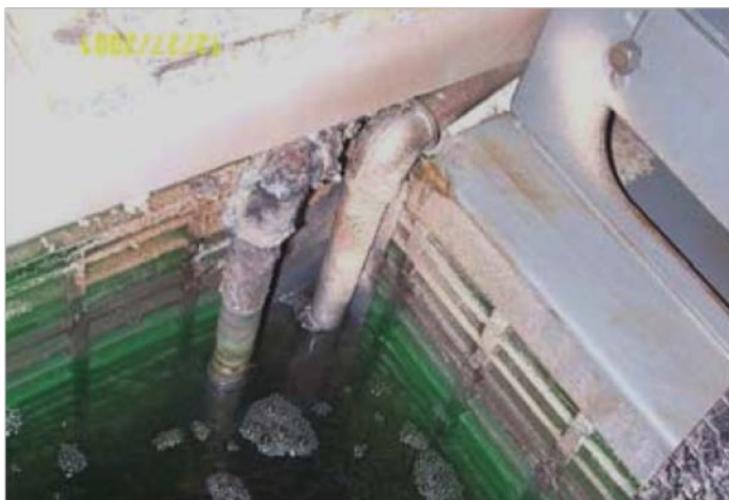
Auxiliary equipment should be protected from stray current by the following guidelines.³⁵ Water and steam connections to heat exchangers (and to any other electrically conducting immersion heater) should contain dielectric unions in both the inlet and outlet lines, and use nonconductive bolt washers and sleeves on mounting hardware to avoid making an electrical ground through which stray current will pass. As an example, steam coils can be cathodically protected by making good connection to tank walls. Use of a dielectric union is recommended to prevent stray current from flowing to adjacent equipment. Evidence of auxiliary equipment stray current is usually manifested in the associated piping, and not the parts but the resulting corrosion products will contaminate the process solution with soluble and insoluble iron (Fig. 10).

Figure 10 - Evidence of auxiliary equipment stray-current protocols being violated.
