## NASF SURFACE TECHNOLOGY WHITE PAPERS 79 (9), 1-9 (June 2015)

### Electroless Nickel-plated Steel versus Stainless Steel: Case Studies

by  
Lloyd Ploof\*\*  
Metalchem, Inc.  
Greer, South Carolina, USA

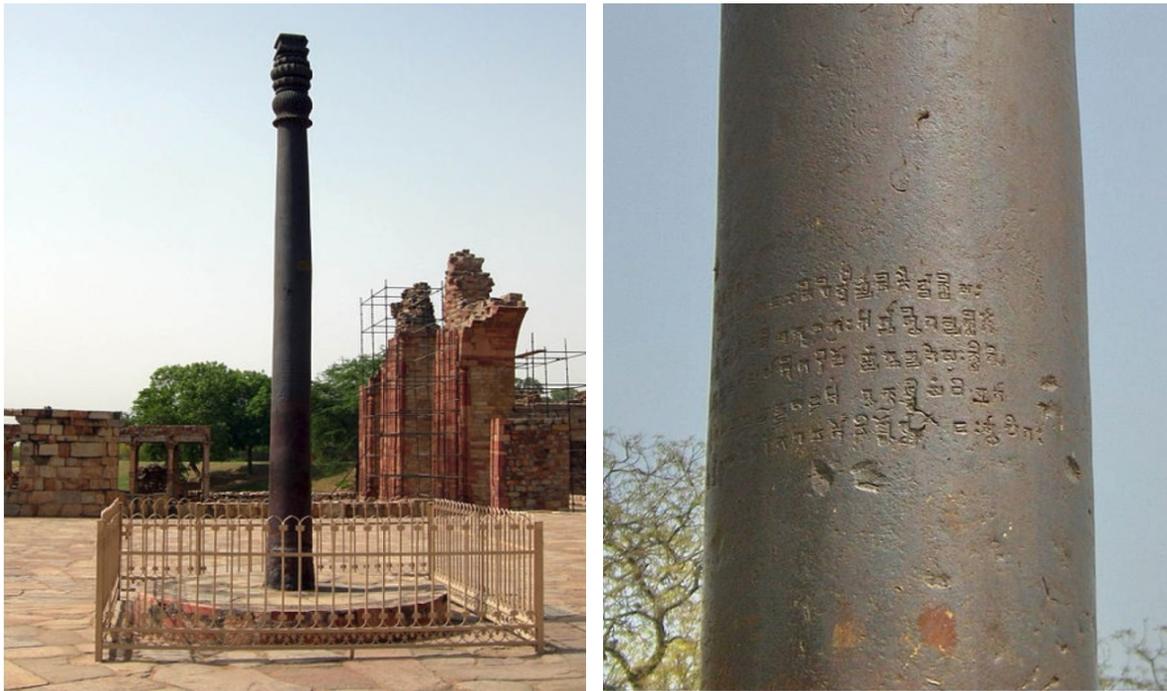
Figure 1 - (a) Iron Pillar of Delhi, 1600 years old; (b) Close-up showing minimal corrosion.

Corrosion resistant steels have been in existence for well over a thousand years. One of the earliest examples is the Iron Pillar of Delhi (Fig. 1). This Hindu monument was constructed around 400 A.D. from an iron-, and interestingly enough, phosphorus alloy. Its longevity and corrosion resistance are due to the formation of a phosphate film on the surface of the metal. After 1600 years in the open air, it has barely corroded, and the phosphate film has grown by just 1/20 of a millimeter.

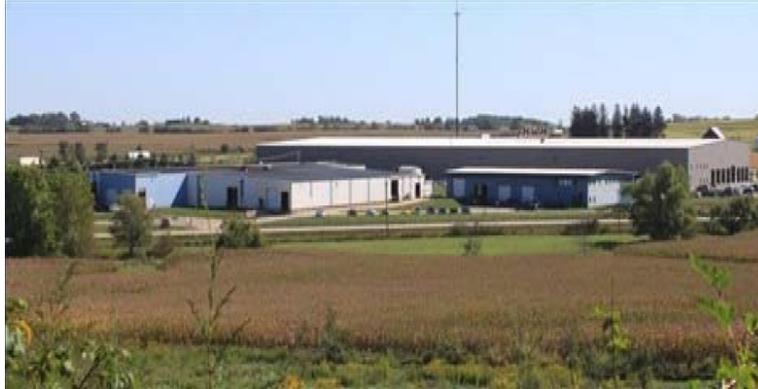
### Case Study #1: Manufacturer of hydraulic load leveling systems

HWH Corporation is a manufacturer of load leveling systems for recreational vehicles (RVs) and campers, among other things. They are located in Moscow, Iowa and employ 300-400 people. The company was founded in 1967 and for the first 17 years of business they designed and manufactured machines and hydraulics for agricultural customers, including John Deere and Caterpillar. During those early years in the agricultural industry, they also discovered a niche for supplying hydraulic leveling systems to the RV industry (because the RV industry was currently borrowing agricultural equipment to meet their needs). HWH has since led the RV industry in hydraulic and air leveling technology. They've introduced countless novel hydraulic slide-out systems to the market and have brought many other hydraulic/air solutions to the RV market, ranging from hydraulic step systems to air suspension systems to saddle-rack systems, as shown in Fig. 2. Most of the hydraulic shafts were made from 303 and 304 stainless steel, and while performing well, they were very expensive to manufacture. Further, during the early and mid-2000s, stainless steel prices rose sharply, and correspondingly, the availability decreased dramatically. HWH began to look for alternatives and electroless nickel was one of them.

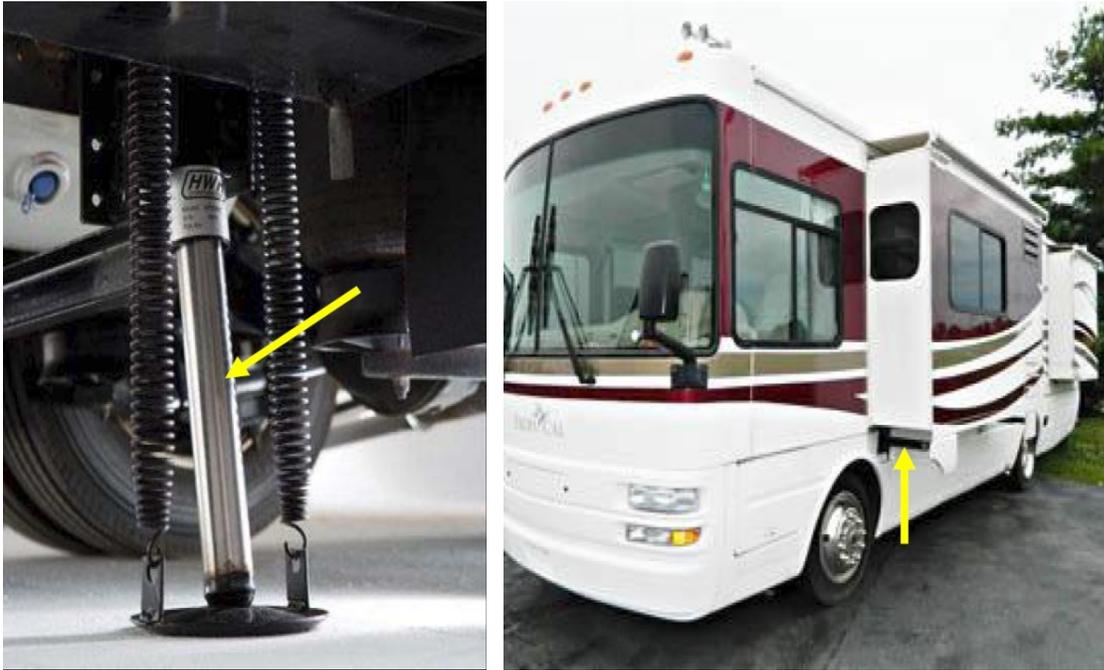
Figure 2 - Products for recreational vehicles and campers: (a) Load leveling jack; (b) RV slide-out system.

After months of successful testing, it was decided to replace the stainless with EN-plated 1026 mild steel on one series of the hydraulic load leveling jacks. A small EN line was installed and, after overcoming the learning curve of becoming platers, limited production began for one year. During this time, no EN-plated jacks came back from the field for failure.

HWH now plates all their hydraulic jack shafts with 0.0015-in. high phosphorus electroless nickel. They use the bath to about five metal turnovers (MTO). At this point, they use this older bath to plate other system parts with EN that would not otherwise get plated, providing even more value to their customers. They coat hundreds of shafts and hundreds of other parts each day.

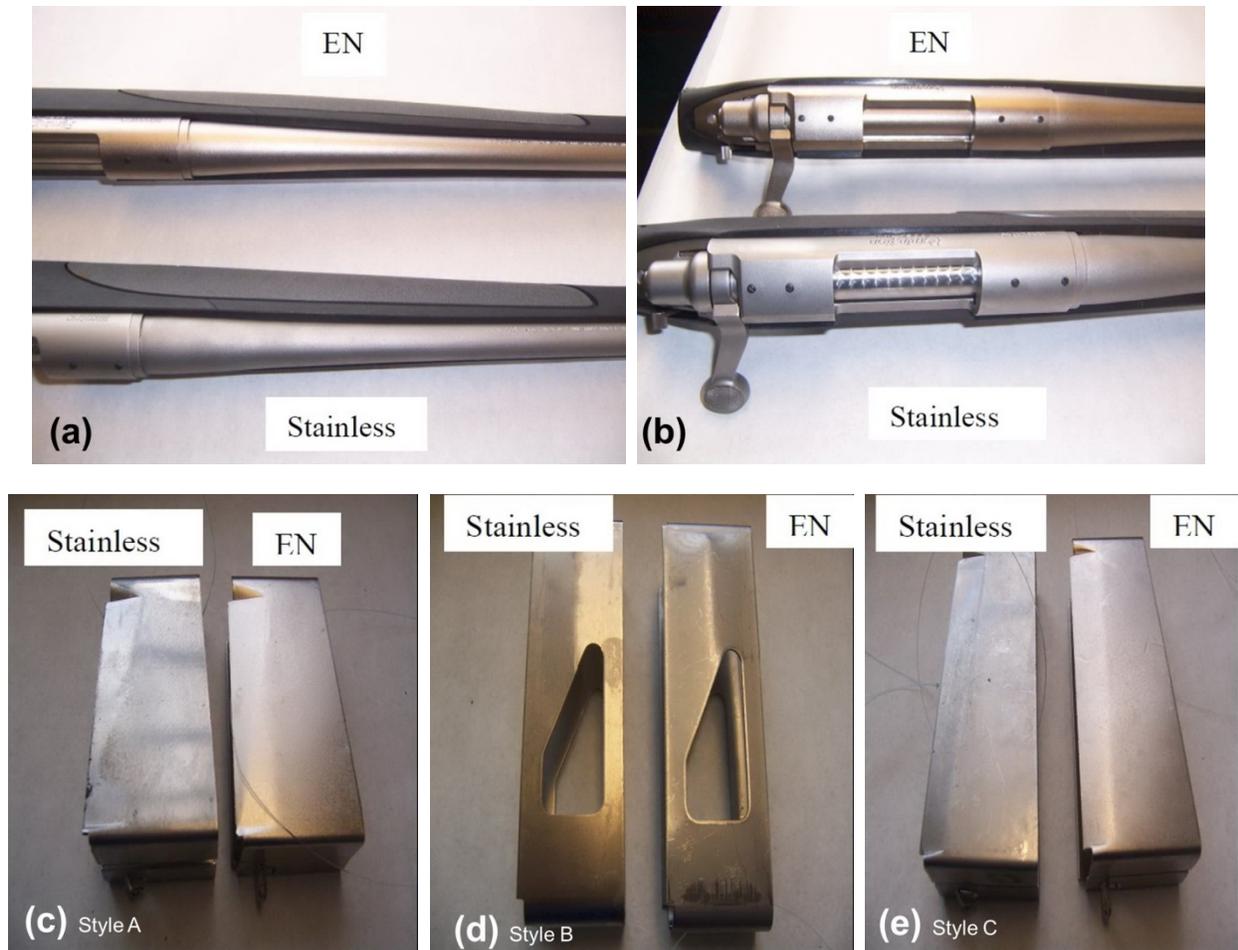
Figure 3 shows the gun parts in the as-received condition, labeled as stainless steel or electroless nickel-plated. The barrels and receivers are shown in Figs. 3(a) and 3(b). The yellowish cast taken on by the electroless nickel finishes is merely a reflection of the surrounding area in the laboratory. Three different magazine box styles are shown in Figs. 3(c), 3(d) and 3(e).

**Figure 3** - Specimens under study in the as-received condition: (a) barrels, (b) receivers, (c) magazine box style A, (d) magazine box style B and (e) magazine box style C. Both stainless and electroless nickel finishes are shown in each photo.

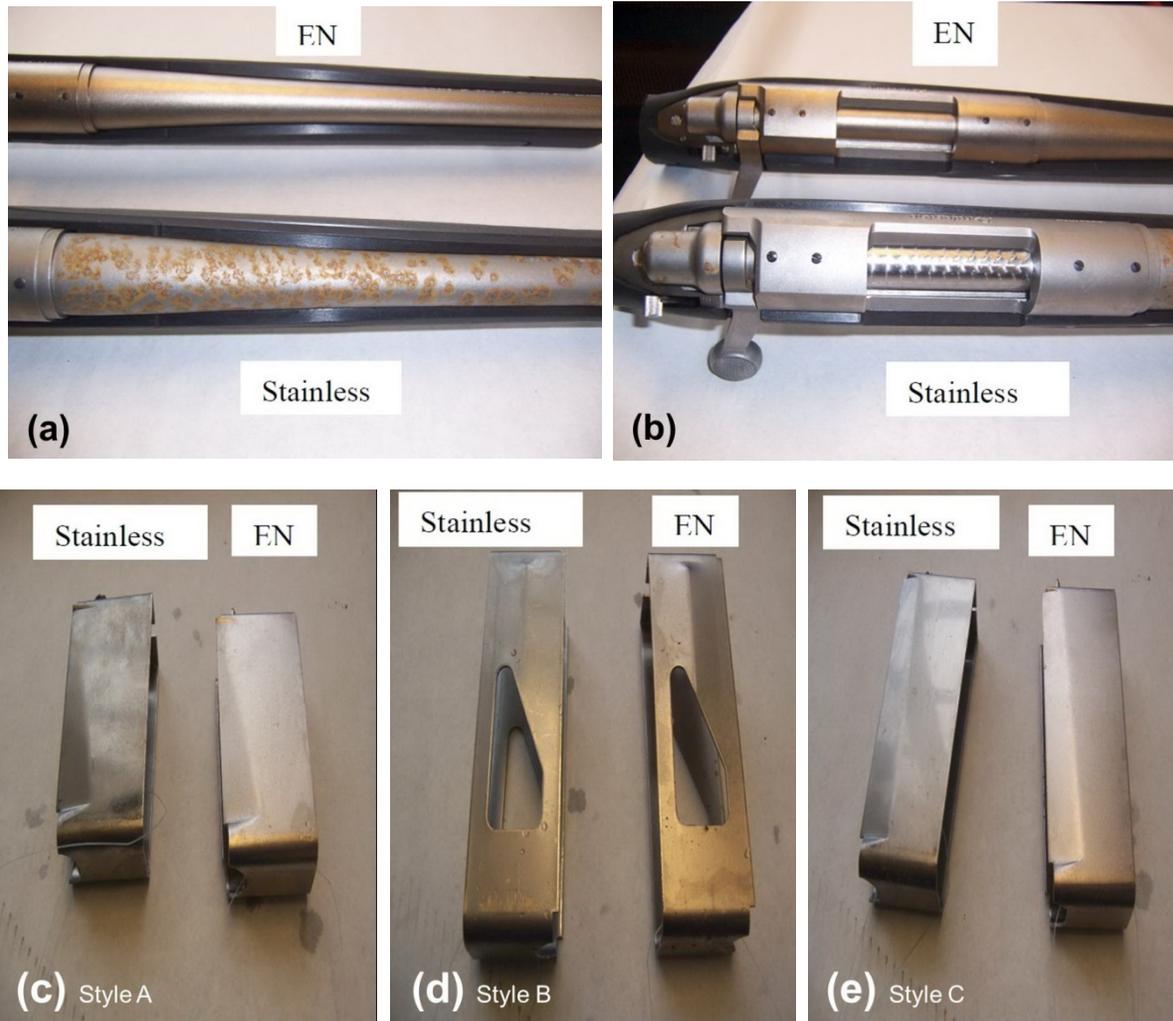
Figure 4 shows the test parts after 4 hours of salt spray, labeled as stainless steel or electroless nickel-plated. The first signs of corrosion are already apparent on the stainless steel barrel (Fig. 4a), as well as on the bolt head area of the stainless steel receiver (Fig. 4b). Mechanically, both actions were fully functioning. No corrosion was noted on the electroless nickel-plated receivers or bolts. Magazine box A (Fig. 4c) showed no rust on the stainless steel finish. Very slight rusting was noted on the shelf area of the electroless nickel-plated box. Boxes B and C (Figs. 4d and 4e, respectively) exhibited no corrosion.

Figure 4 - Corrosion test results after 4 hours of salt spray: (a) barrels, (b) receivers, (c) magazine box style A, (d) magazine box style B and (e) magazine box style C. Both stainless and electroless nickel finishes are shown in each photo.

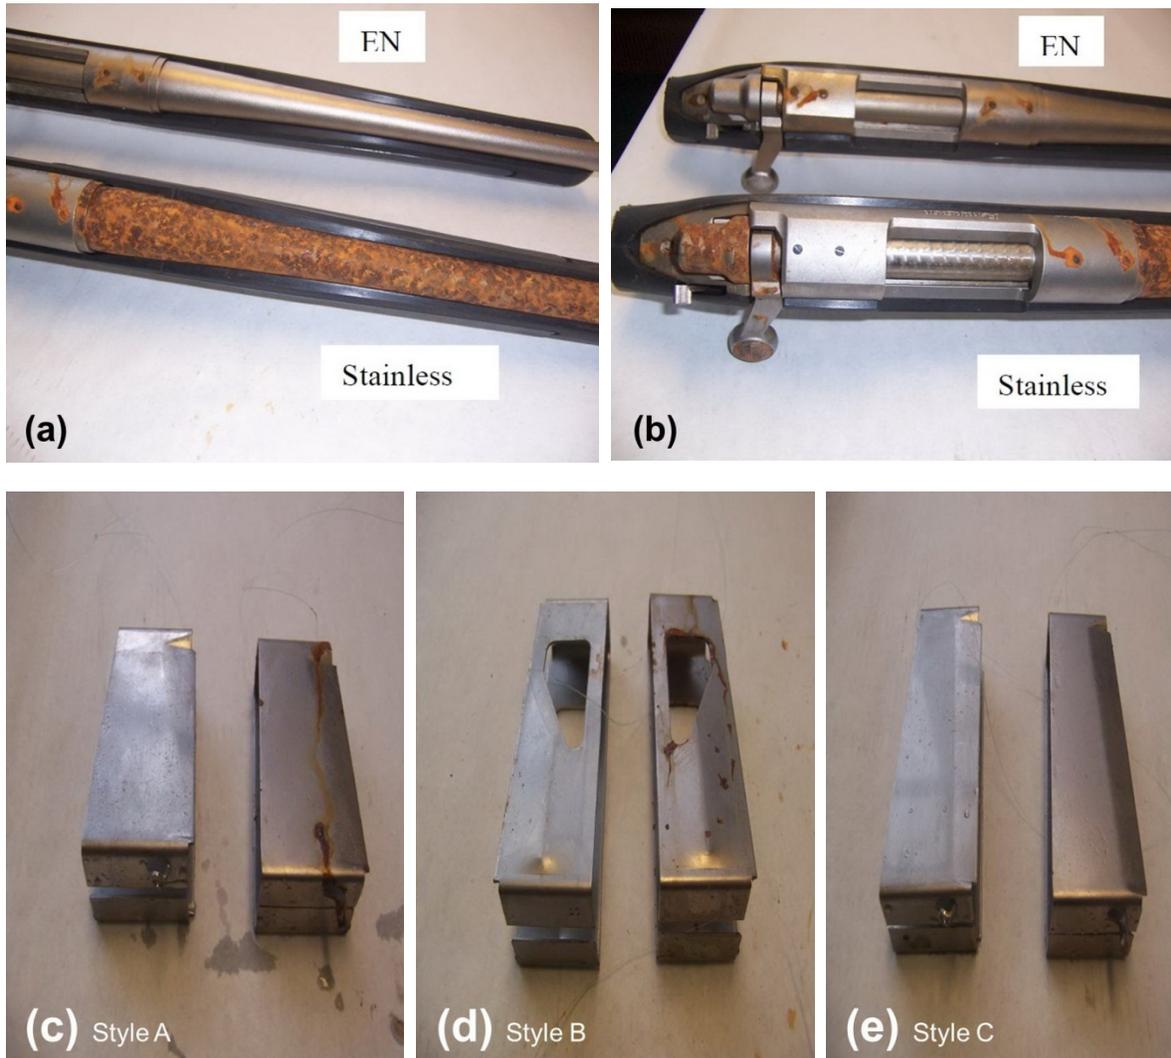
Figure 5 shows the test parts after 45 hours of salt spray, labeled as stainless steel or electroless nickel-plated. 100% red rust was observed on the stainless steel barrel (Fig. 5a), while there was no rust on the EN-plated barrel, except inside, where there was no plating. There was extensive rust on the bolt head of the stainless steel receiver (Fig. 5b), while there was no rust noted on the EN-plated receiver. However, both receivers exhibited corrosion from the steel scope mount screws, which were not stainless, nor were they plated. Mechanically, the stainless steel action was beginning to show resistance. No corrosion was noted on the electroless nickel-plated receivers or bolts. Magazine box A (Fig. 5c) showed no rust on the stainless steel finish and less than 1% rust on the electroless nickel-plated box. Box B (Fig. 5d) showed no rust on the stainless steel finish and less than 2% rust on the electroless nickel-plated box. Box C (Fig. 5e) exhibited no corrosion with either finish.

**Figure 5** - Corrosion test results after 45 hours of salt spray: (a) barrels, (b) receivers, (c) magazine box style A, (d) magazine box style B and (e) magazine box style C. Both stainless (L) and electroless nickel (R) finishes are shown in each photo.

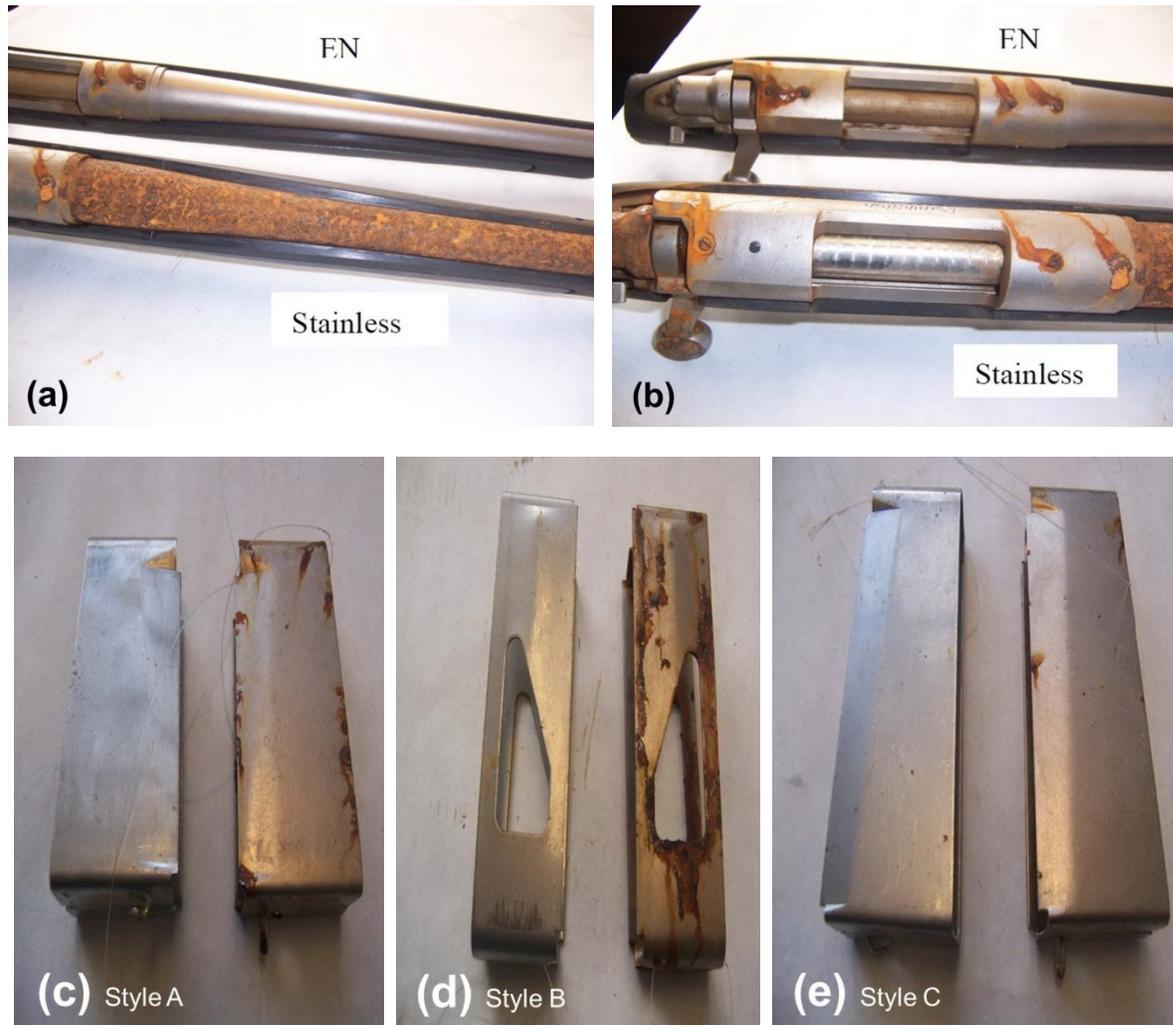
Figure 6 shows the test parts at the end of the test, after 93 hours of salt spray, labeled as stainless steel or electroless nickel-plated. As at 45 hours, 100% red rust was observed on the stainless steel barrel (Fig. 6a), while there was no rust on the EN-plated barrel, except inside, where there was no plating. The bolt head of the stainless steel receiver was 100% rusted (Fig. 6b), with extensive rust on the bolt handle. There was no rust noted on the either receiver except that from the steel scope mount screws. Mechanically, the stainless steel action was completely non-functional, while the EN finish action was still fully functional. No corrosion was noted on the electroless nickel-plated receivers or bolts. Magazine box A (Fig. 6c) showed slight rusting on the stainless steel finish and about 2% rust on the electroless nickel-plated box. Box B (Fig. 6d) showed slight rusting on the stainless steel finish and 5-10% rust on the electroless nickel-plated box. Box C (Fig. 6e) showed slight rusting on the stainless steel finish and less than 1% rust on the electroless nickel-plated box.

**Figure 6** - Corrosion test results after 93 hours of salt spray at the end of the test: (a) barrels, (b) receivers, (c) magazine box style A, (d) magazine box style B and (e) magazine box style C. Both stainless (L) and electroless nickel (R) finishes are shown in each photo.

The electroless nickel-plated 1155 steel gun significantly outperformed the 416R stainless steel gun in corrosion resistance as tested with neutral salt spray. The 416R stainless steel barrel began to show red rust within a few hours of being subjected to salt fog, where, at the end of the test at 93 hours, the EN-plated barrel exhibited no corrosion on the outside of the barrel where it was coated. On the inside of the barrels, where there was no EN coating, the barrels exhibited similar rusting conditions.

Oddly, the 416R stainless steel receiver performed as well as the EN-plated 1155 steel receiver. It was surmised that this was because the receiver was subjected to a different heat treat cycle than the barrel.

The stainless steel magazine boxes, being made of the more corrosion resistant 304 stainless steel, outperformed the EN-plated magazine boxes, but not by the overwhelming margin that the EN-plated barrel outperformed the stainless steel barrel. It should be noted again that the EN thickness on the magazine boxes was minimal at 0.0002-0.0004 in. Further, it can be reasonably
