The 48th William Blum Lecture
Presented at NASF SUR/FIN 2010
in Grand Rapids, Michigan
June 14, 2010

Decorative Electroplating: Theory to Explain Rapid Corrosion Due to Calcium Chloride 'Russian Mud'

by
Dr. Donald Snyder
Recipient of the 2009 William Blum
NASF Scientific Achievement Award

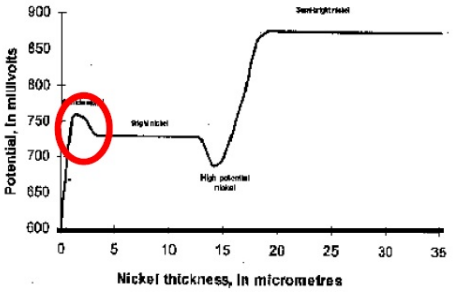
Appearance of Active Sites not objectionable – reflectivity maintained

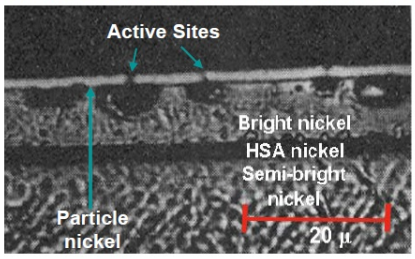
Classical corrosion of nickel/chromium

The substrate is protected while maintaining the reflectivity of the surface

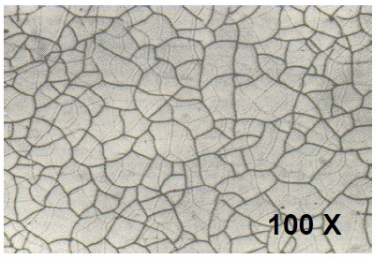
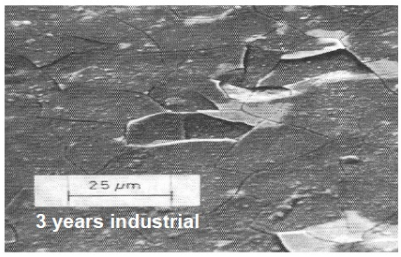
Corrosion of Micro-discontinuous Chromium
Micro-Cracked Chromium

Undercutting of the chromium occurs due to "active" highly stressed micro-cracked nickel layer

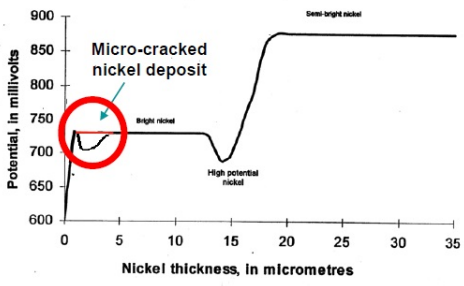
Reflectivity is reduced

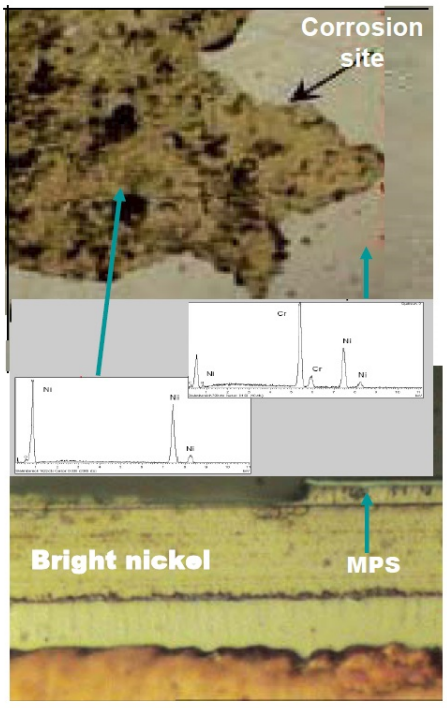
Moscow vehicle with corrosion in less than one year

"Russian Mud"

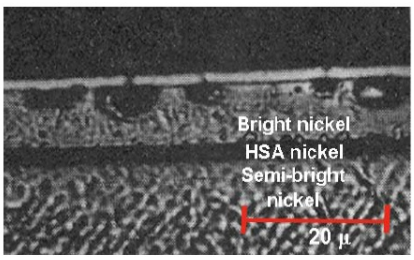
Warranty Return

Moscow winter of 2006-2007

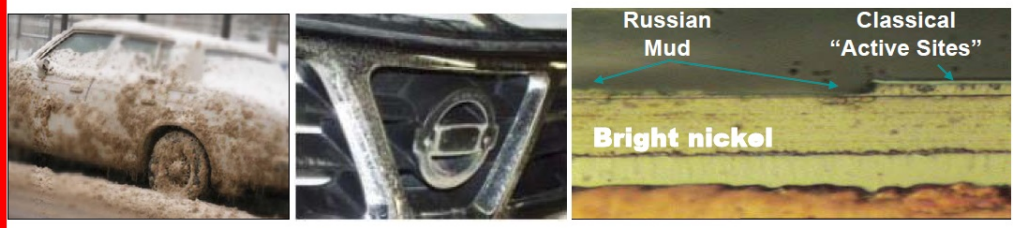
Factors required to produce "Russian Mud" corrosion

Laboratory and field studies established that <u>three factors</u> must be present for rapid "non-classical" accelerated corrosion to occur

1. **Minimum concentration of <u>chloride</u>**
   - **calcium, magnesium, sodium**
2. **<u>Moisture</u>**
   - **Water / humidity**
3. **Solid <u>particles</u>**
   - **"Mud"**

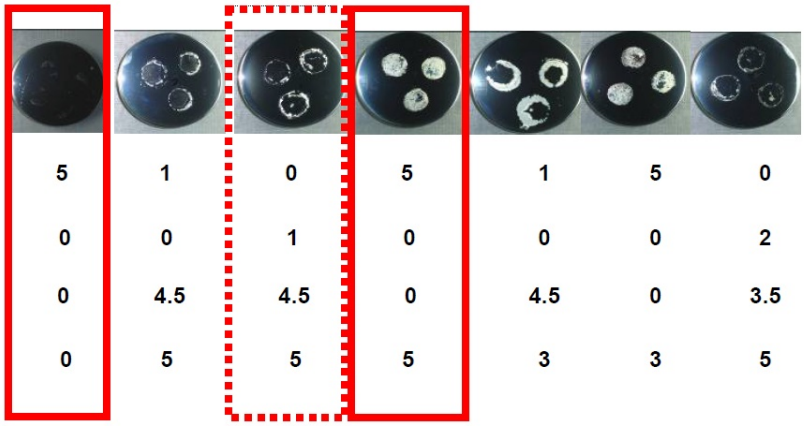
Corrosion after 48 h at 60°C and 23 % humidity

Kaolin (solid), chloride and water are needed to produce a visible corrosion of the chromium surface

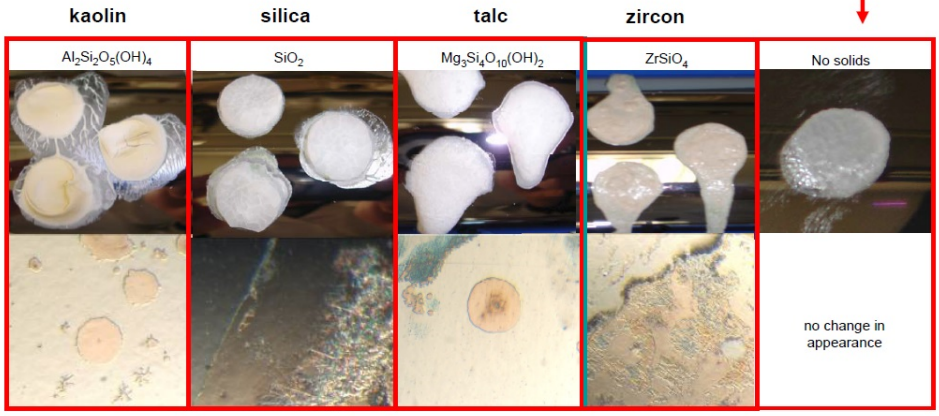
Similar corrosion was observed when many different solids were used with the Nissan Test

- Kaolin is being used to simulate the dirt from the roads.
- With other solids the corrosion of the chromium is distinctly different, but clearly visible.
- Without any solid, the corrosion of the chromium is negligible.

Data indicates that any solid will participate in this form of corrosion

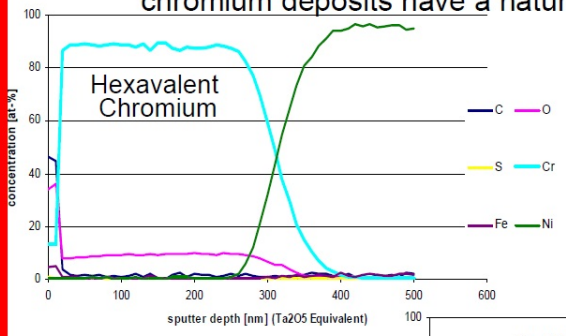
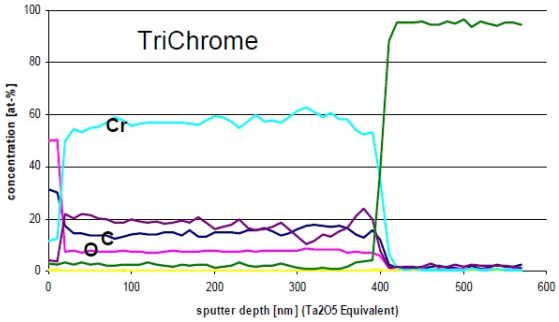
Depth profile of electroplated chromium

chromium deposits have a natural coating high in oxide

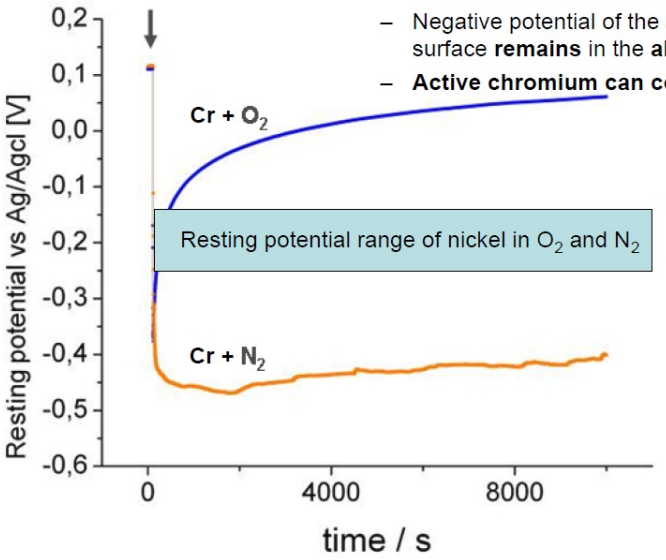
Mechanical damaging of the electroplated chromium surface with a glass pipette in a saturated calcium chloride solution

- **Presence of O_2** leads to **fast re-passivation** of the chromium surface
- Negative potential of the **active chromium** surface **remains** in the **absence of O_2**
- **Active chromium can corrode at** -0.45 V

Active chromium is more reactive than nickel

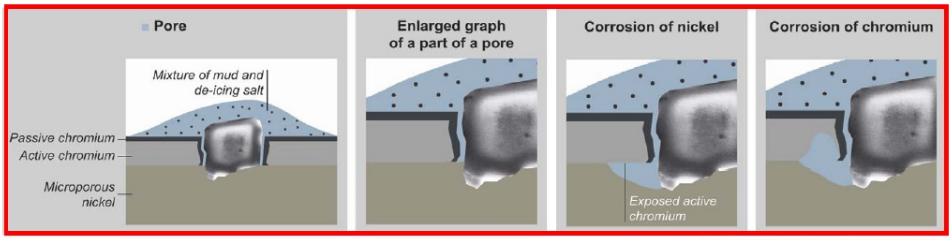
Theory - Corrosion of Micro-porous Chromium

- **Since nickel dissolution in the pore occurs in a lateral direction, active (non-surface) chromium is exposed.**
- **Dirt (e.g. kaolin) in the pore delays the diffusion of oxygen into the pore and thereby prevents the passivation of the active chromium.**
- **The active chromium corrodes lateraly and upward.**
- **Oxygen reduction at the surface of the passive chromium is the counter reaction for both the nickel and the chromium corrosion.**
- **Same reaction takes place with sodium chloride if chloride and moisture are maintained**

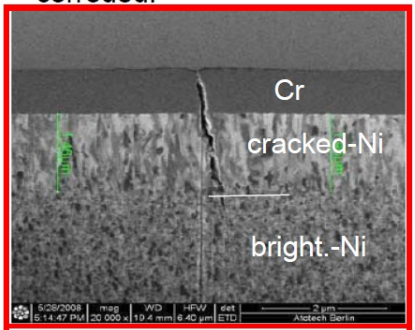
Field damage

Hypothesis: Micro-cracked Nickel / HexChrome

- The nickel corrosion not only takes place directly underneath the chromium layer, but also deeper into the crack towards the bright nickel.
- Continuous cracks can encourage the continuous passivation of the chromium deposit. Easy path for oxygen.
- The bright nickel and micro-cracked layers are preferentially corroded.

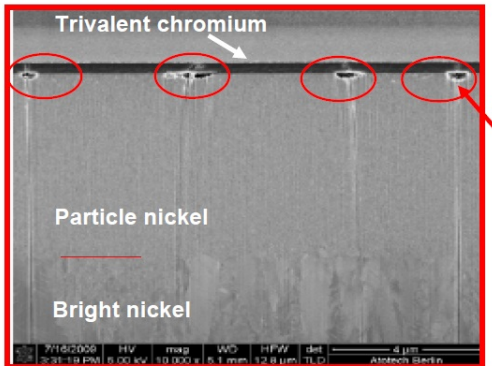
Hypothesis: Micro-porous Nickel / Trivalent Chromium

- Tested trivalent chromium deposit is an alloys making it more complex in composition
- Chromium layers from the tested trivalent chromium electrolytes are always more noble than those from hexavalent electrolytes
- Nickel corrosion takes place in the micro porous / noble nickel layer under the passive trivalent chromium
- Corrosion mechanism is similar to traditional one since tested trivalent is passive throughout the deposit

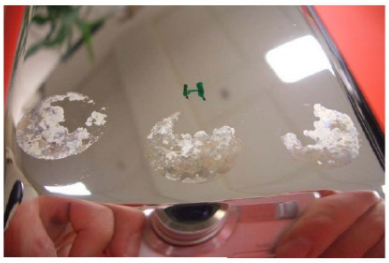
Hexavalent chromium

Nissan Russian Mud Test – Hexavalent versus Tested Trivalent

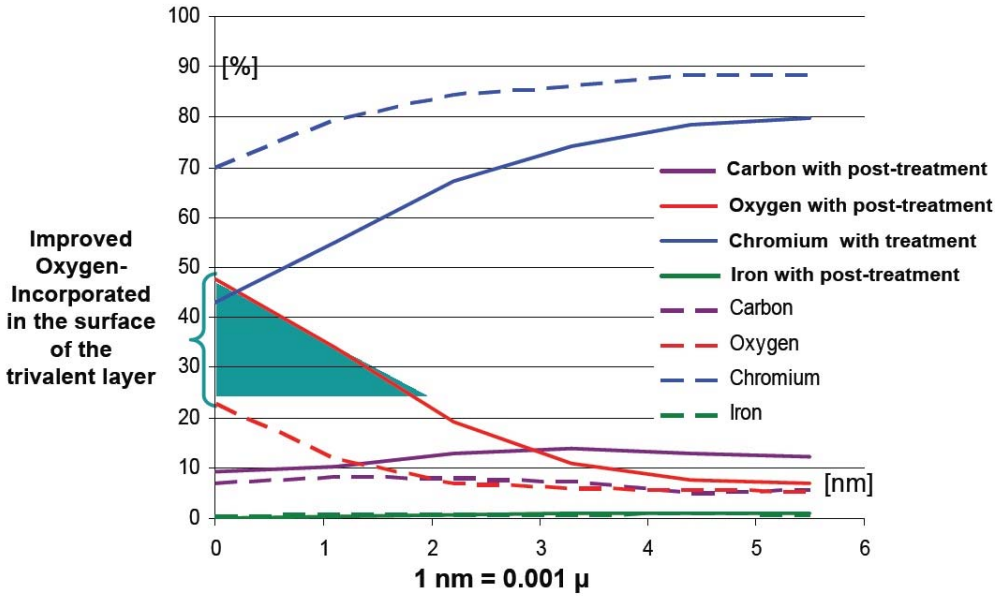
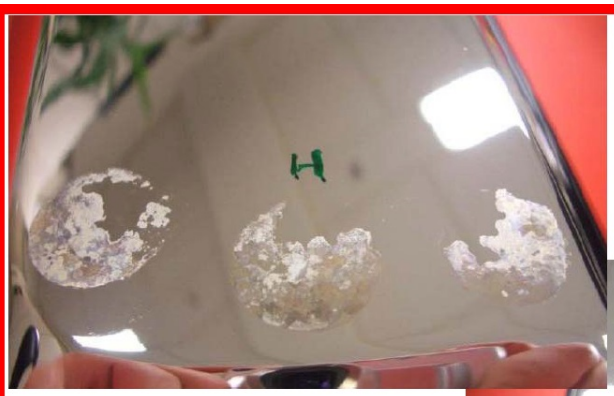
Deposits after 168 hours of Nissan Russian Mud Test

Trivalent chromium + Post treatment

Increase the level of oxygen on the surface by the use of a post-oxidizing step
